What is the Stormwater Monitoring Coalition (SMC)?

Program update

What are the biological conditions in engineered channels?

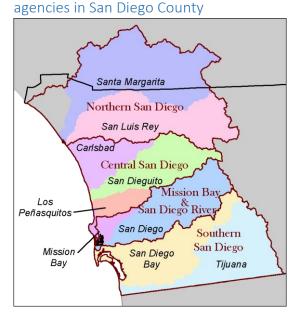
San Diego Watershed Management Areas (black text) nested within SMC watersheds (brown text). Local jurisdictions take the lead in monitoring each WMA and setting management priorities, contributing to and making use of the SMC's regional survey.

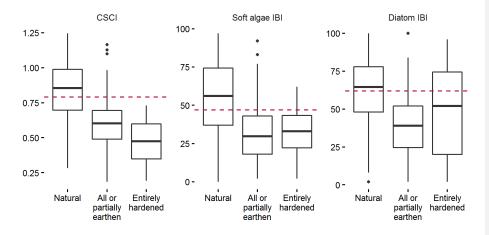
Figure 2. Bioassessment scores were typically higher in natural than in engineered channels. However, high scores for the algal indices were sometimes observed in engineered channels, occasionally exceeding the threshold for identifying sites in reference condition (red dashed line).

Algal indices, however, provided different insights into stream condition. While the diatom and soft algae IBIs, like the CSCI, showed that engineered channels were generally in worse condition than natural channels, high algal IBI scores indicative of healthy (i.e., similar to reference) conditions were not uncommon. In fact, 43% of hardened channels had diatom IBI scores above the reference threshold, and 20% had high soft algae IBI scores. Whereas the CSCI indicated almost exclusively poor conditions in engineered channels, algal indicators suggest that engineered channels can support healthy streams under conducive conditions (such as good water quality).

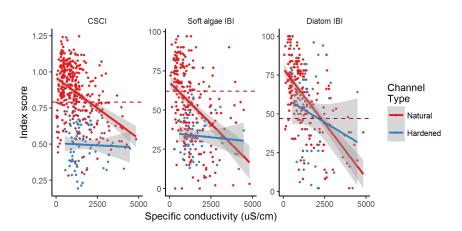
Figure 3. Specific conductivity versus bioassessment index scores in hardened and natural channels. The red dashed line is the threshold for sites in reference condition. For clarity, earthen and partially hardened channels are excluded from this plot.

Analyses of the data provide some support for this hypothesis. The diatom index responded to a range of water quality conditions, even within concrete channels (Figure 3, Table 1). For example, the diatom IBI declined with increasing specific conductivity in all channel types, whereas scores for the soft algae index and the CSCI exhibited responses within natural or partially earthen channels. The hypothesis that the constraints within engineered channels overwhelm the ability of bioassessment indicators to respond to stress is not well supported for diatoms.

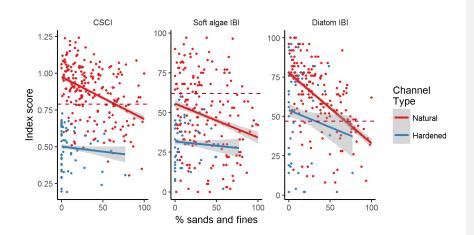
Figure 4. Percent sands and fines in the streambed versus bioassessment index scores in hardened and natural channels. The red dashed line is the threshold for sites in reference condition. For clarity, earthen and partially hardened channels are excluded from this plot.

Factors related to habitat showed a similar pattern of responses. For example, high levels of sands and fines in the streambed were associated with lower scores for all indices, but the relationships within hardened channels were strongest for the diatom index (Figure 4). Although the CSCI did not respond to many water chemistry and physical habitat gradients within hardened channels, shading and temperature appears to be important for this index, with higher scores observed in hardened channels where shading was high (Figure 5). Stream-side vegetation, which is often removed for flood control purposes, may provide the conditions that improve CSCI scores. However, shading had the opposite relationship with diatom IBI scores, and no relationship with soft algae IBI scores.

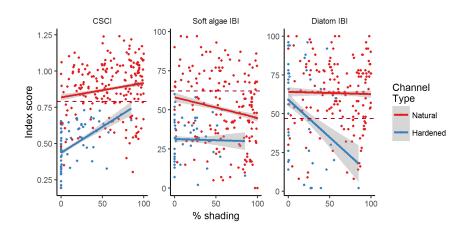
Figure 5. Shading versus index scores in natural and hardened channels. The red dashed line is the threshold for sites in reference condition. For clarity, earthen and partially hardened channels are excluded from this plot.

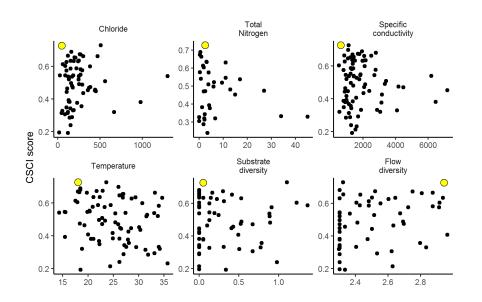
Figure 7. CSCI scores versus water quality and habitat metrics in hardened channels. The large yellow symbol represents Little Dalton Wash.

The field conditions at Little Dalton Wash are not different from other hardened channels in any obvious way. The sampled reach is in a rectangular concrete box that lacks low-flow features. Located in the midst of a heavily developed area, it receives drainage from a 27-km² watershed that is more than one-third urbanized. However, comparison with survey data from other hardened channels suggest a few possibilities. Several water quality analytes, as well as physical habitat metrics, were better at Little Dalton Wash than at lower-scoring hardened channels, including chloride, total nitrogen, temperature, and specific conductivity (Figure 7). The diversity of flow microhabitats (e.g., riffles and glides) was high as well. These factors may explain the higher scores observed at this site.

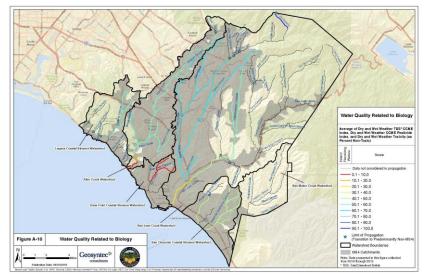
Figure 1. Excerpt from the San Juan Water Quality Improvement Plan shows how the County of Orange used SMC bioassessment and water quality data to prioritize problem areas in the watershed. Red, orange, and yellow stream segments have low-scoring bioassessment sites, in conjunction with measures of poor water quality. A separate analysis identifies stream reaches where low-scoring bioassessment occur in conjunction with geomorphic alteration.

The WQIP identified three priority problems, and two of them were determined through bioassessment data: geomorphic alteration, and unnatural flow regimes. These problems were identified by the association of stressors related to these problems (e.g., hydromodification and habitat degradation), and their relationships with poor bioassessment index scores (Figure 1). Best management practices to mitigate these stressors will be identified, and their success will be partly determined in terms of improvements in biological condition. The monitoring and assessment component of the WQIP is currently under preparation, and it is expected that biological monitoring through the SMC stream survey will play a crucial role in this component.
